DEPARTMENT OF NATURAL RESOURCES
DIVISION OF OIL, GAS AND MINING

RE: Site Inspection, Tintic Utah Metals, LLC, Burgin Mine, M/049/009, Utah County, Utah

Date of Inspection: September 18, 2001

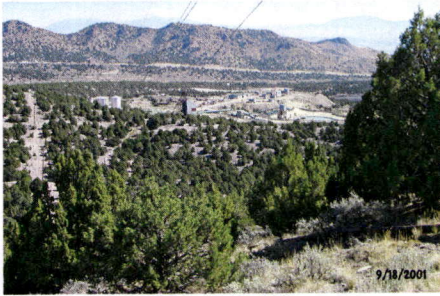
P0001907.JPG
09/18/1901

BURGIN MINE
SITE

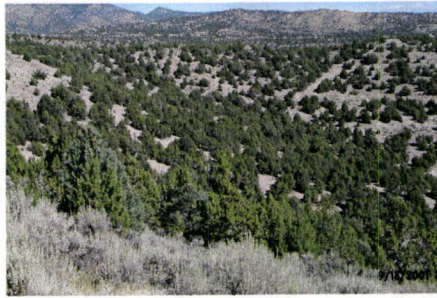
P0001908.JPG
09/18/1901

We mentioned some cleanup items on drill holes draining into Silver Pass Canyon Drainage. From the Apex #2 site, we walked to the top of an adjacent knoll to look down into the valley below so we could see the site of the proposed Hunter Shaft that was never constructed. This site was scheduled for release from the permit.

AREA WHERE
HUNTER SHAFT
WAS PROPOSED

It is recommended that the Hunter Shaft, the Settling Ponds, and the Burgin Tailings ponds be released from any further reclamation liability.

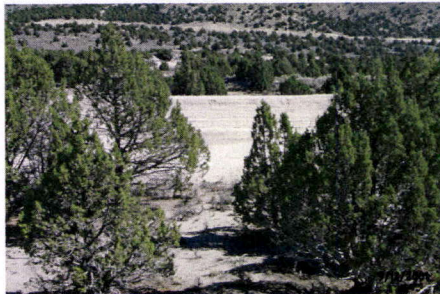
P0001910.JPG
09/18/1901

embankment. Another ditch was observed coming into the sediment pond which was not explained in the plan. The by-pass ditch that was permitted was meant to by-pass the sediment pond and go to the railroad embankment. A clarification of this system will need to be given if there is another ditch in the system. Maintenance of all ditches was determined to be a necessity in the future, given the erodible nature of the soil and the vegetation in the area.

SEDIMENT POND
EMBANKMENT

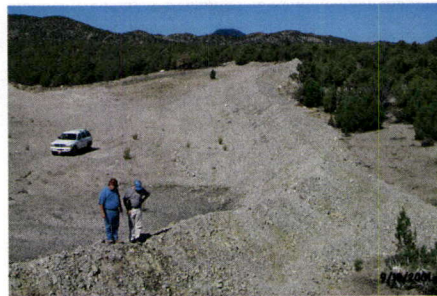
P0001911.JPG
09/18/1901

EMBANKMENT
FOR WASTE DISPOSAL
AREA

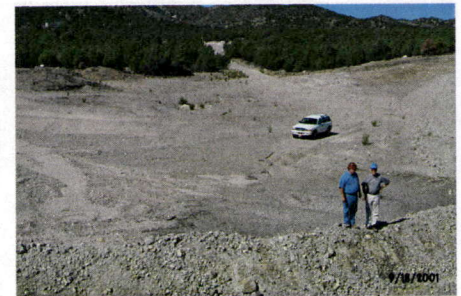
P0001912.JPG
09/18/1901

The dry stack tailings area, by-pass ditch, sediment pond, and railroad embankment below were inspected next. The area of the dry stack tailings had been scarified and topsoil removed. A buried decant system was in place which drains to the sediment pond immediately below the

WASTE DISPOSAL
AREA CLEARED
DRY STACK

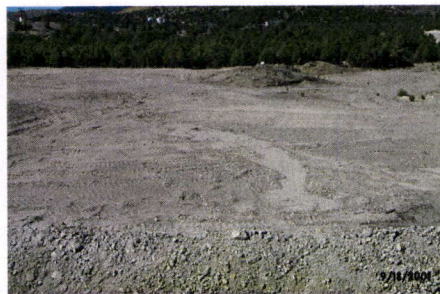
P0001913.JPG
09/18/1901

Dry Stack Tailings
Disposal Area

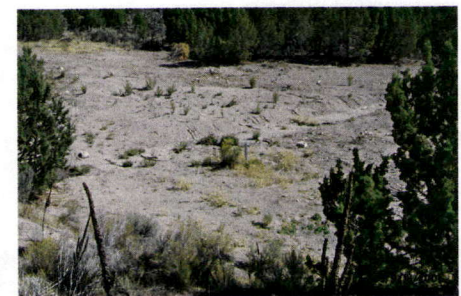
P0001915.JPG
09/18/1901

After finishing with this area we drove to the settling ponds area that was requested for release. These ponds have not been used for a period of time, in excess of 15 years. The pond areas were revegetated; therefore, regrading was not an issue. The ponds do not appear to be a problem for any apparent reason.

settling ponds
grown back
